Combination MFL/Deformation Inspections of Small-Diameter Unpiggable Pipelines.

by Ken Maxfield
KMAX Inspection

Pipeline Pigging and Integrity Management Conference

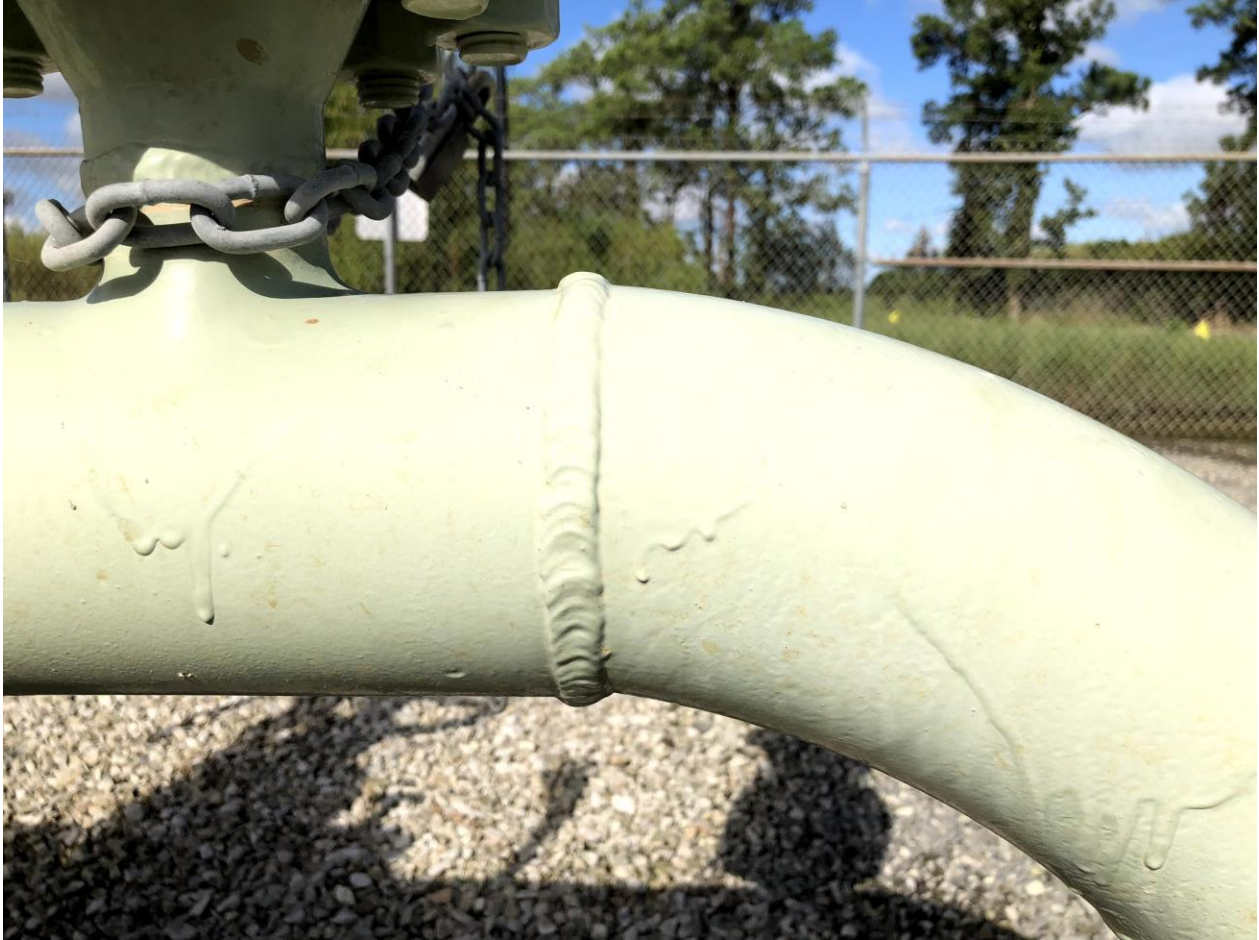
The pipeline was built in the 1960's with schedule 40 pipe. Later in 1980's the pipeline was modified by the installation of two above ground valves. The above ground valves were designed and installed with schedule 80 pipe and fittings. Forty-five (45) degree, schedule 80 bends were used to bring the pipe out of the ground and turn the pipe horizontal above ground.

The 3.6" restrictions detected by the geometry tool were associated with the girth welds of the 45-degree, schedule 80 bends and the adjacent pipe or fittings.

Figure 1 Location of 3.6" Restriction--Sch. 80 Bend and Tee (Note the High/Low Weld)

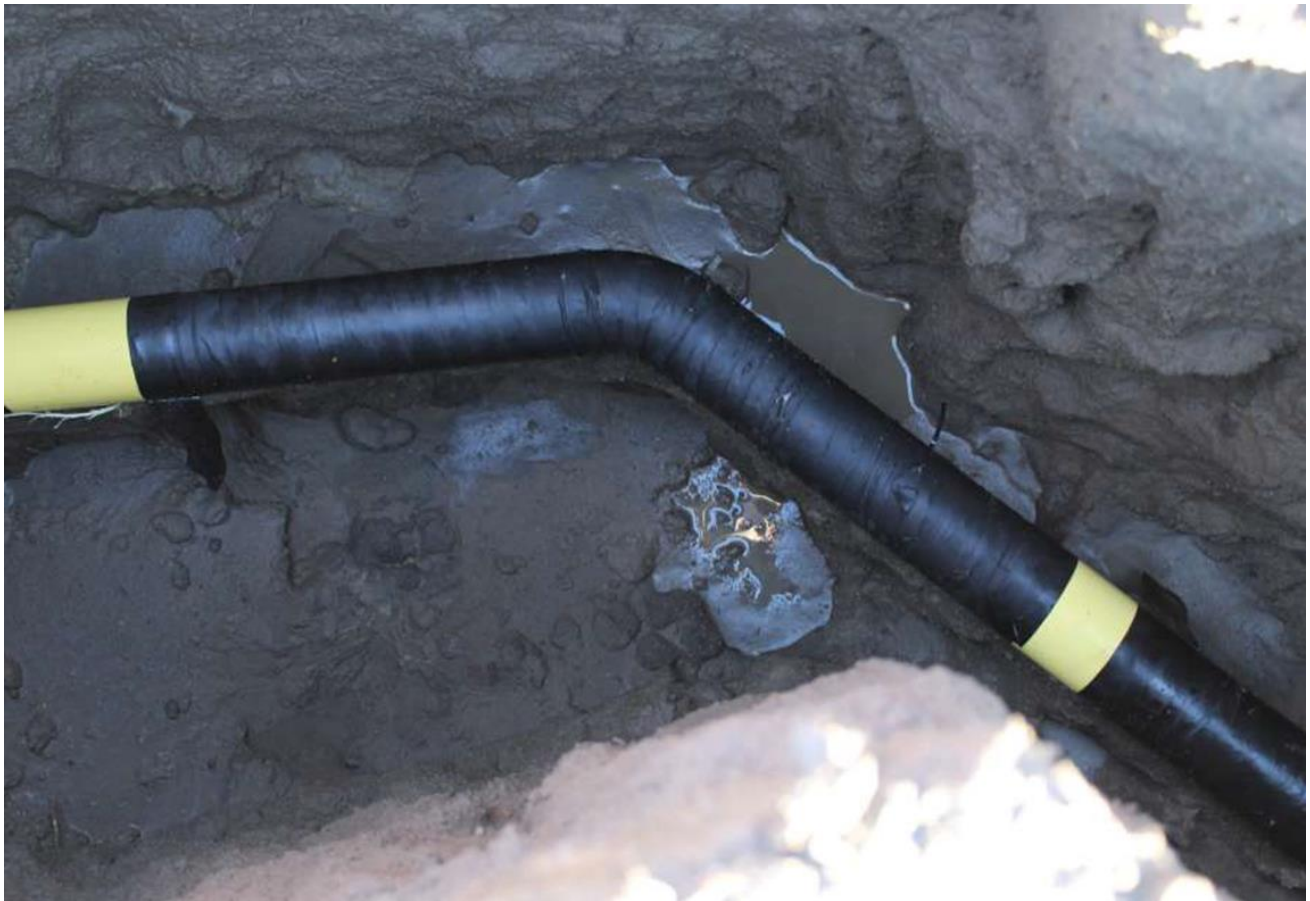
KMAX was contacted about inspecting a 3", 2-mile, Natural Gas pipeline. The line had never been inspected by an inspection tool. The nominal wall thickness was .156 ERW pipe, with potentially thicker wall thicknesses in the pipeline. The pipeline was constructed in 1962. There was no launcher or receiver facilities installed on the pipeline. The line had a 1.5d, 45deg, schedule 40 bend installed. The pipeline normally operated at a low pressure of around 100 psi.

Figure 9 A confirmed 1.5d, 45 deg. bend in the pipeline.

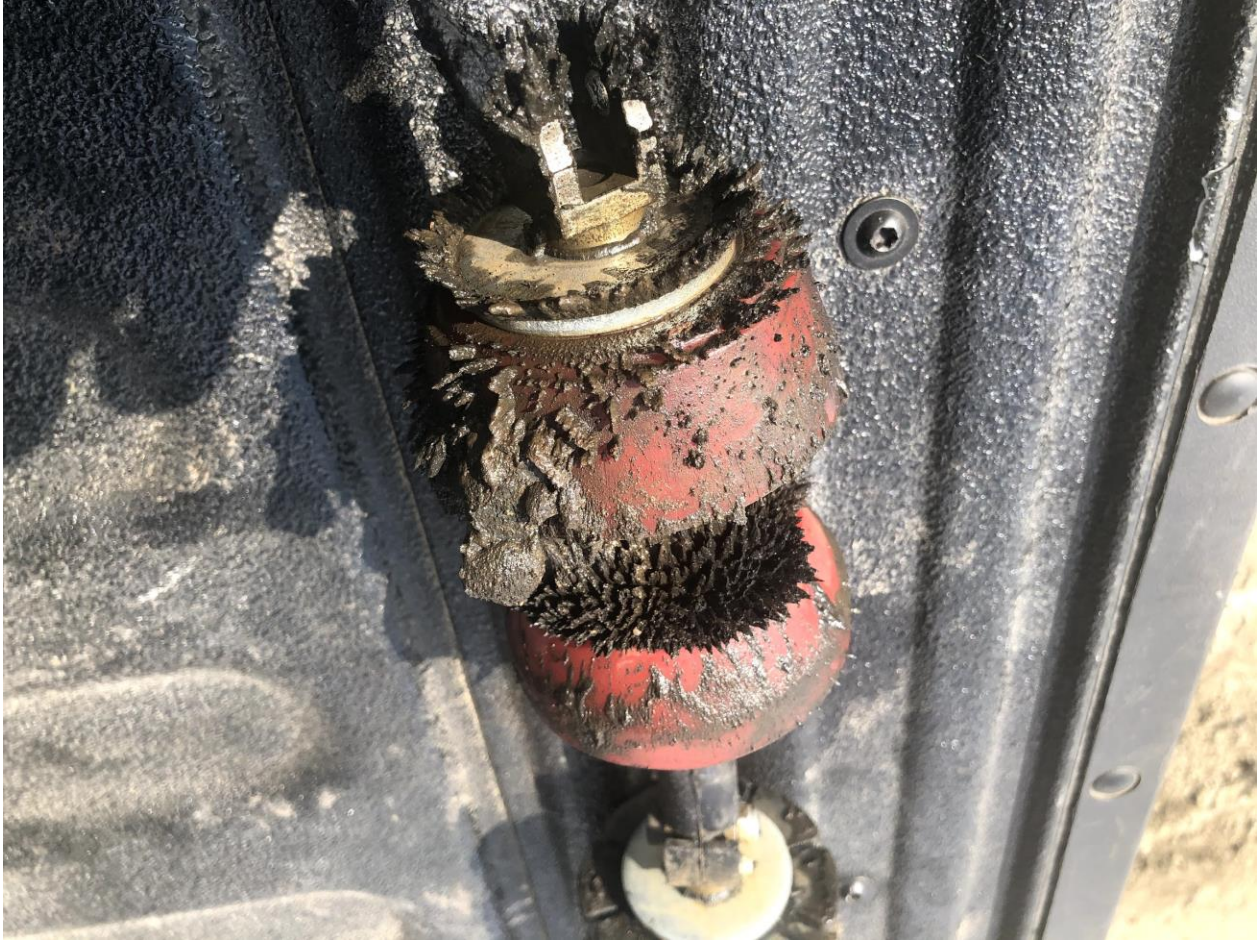
The cleaning/gauge pig had ferrous debris on it after the first pass, so it was decided to run the pig a second time to get the line clean.

Figure 11 Debris on Magnets of Cleaning Pig

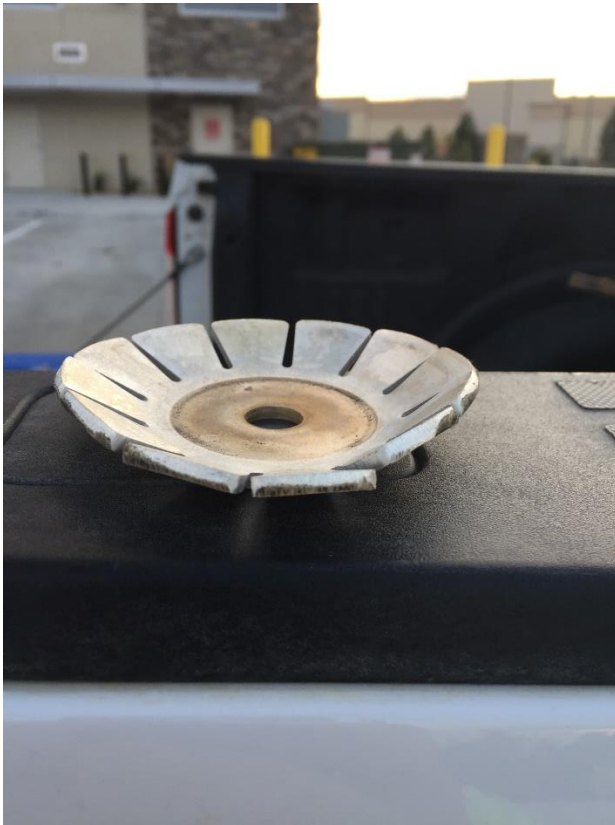
The KMAX cleaning/gauge tool was run through the line. The gauge plate came back with bent tabs. The diameter of the gauge tool was 3.25" and the damage was full circumferential.

Figure 12 The Gauge Plate Showing Damage Around the Full Circumference of the Plate

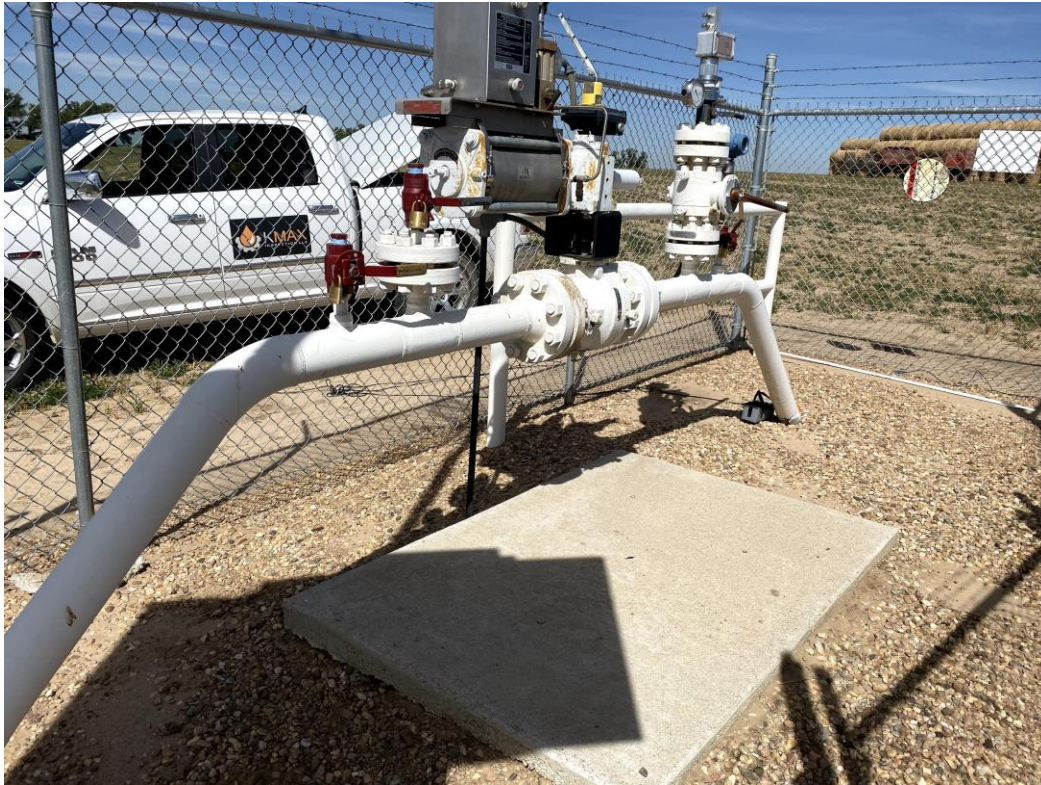
Once the data from the Deformation tool was evaluated it showed that the pipeline had extra heavy fittings at the launcher, at the 3 above ground valve settings, and at the receiver.

Location	Minimum Bore
Launcher	3.45" in Tee
Above Ground Valve Setting	3.43" in Tee
Above Ground Valve Setting	3.23" in Tee
Above Ground Valve Setting	3.48" in Tee
Receiver	3.36" in Tee

Figure 13 Above Ground Valve Setting with Heavy Wall Tee

This case study helps identify some of the issues that are common with fittings that are installed on small diameter pipelines. Extra Heavy tees were used, with a wall thickness as thick as .635" for a 4" pipeline. The tees installed were rated for 4,529psi, while the established MAOP on the line was 1,440psi. While these fittings may be strong, they exclude any ability to run ILI tools, and they can restrict the throughput of the pipeline.

Pipeline Operators or designers are cautioned about using heavy wall fittings on small diameter pipelines. There is no minimum bore requirements for fittings. ASME B16.9 states “Bore diameters away from the ends are not specified. If special flow path requirements are needed, the bore dimensions shall be specified by the purchaser.”ⁱⁱⁱ

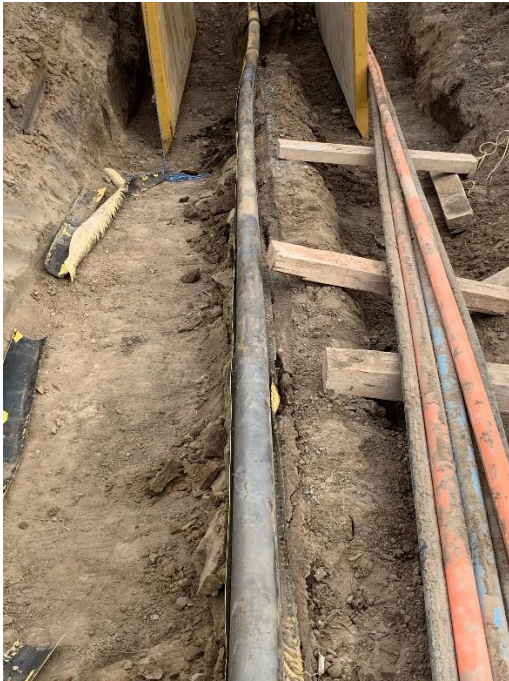
The pipeline operator decided that the number of repairs necessary to be able to run the KMAX MFL tool was too extensive and decided to hydro test the pipeline. The operator did investigate the 12.2% dent. The dent was caused when a fiberoptic cable was installed parallel to the 4" pipeline. A boring machine was used to install the cable and during the process damaged the 4" pipeline. This section of pipe had to be replaced due to the damage.

Figure 13 4" pipeline with Fiberoptic Cables in Same Right-Of-Way

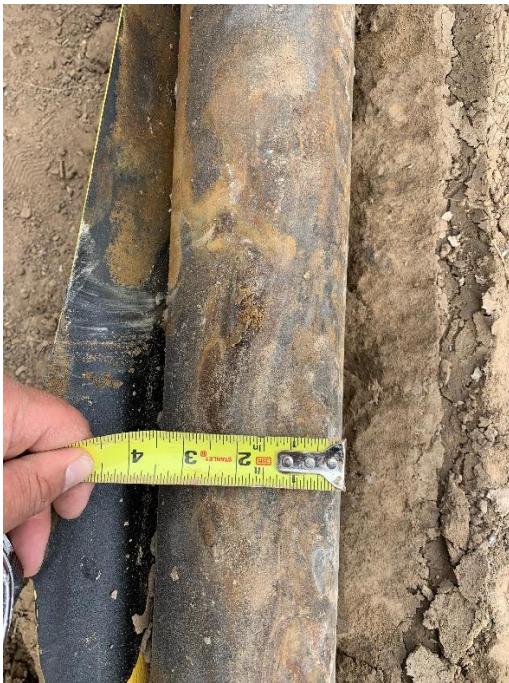
In addition, there were 4 dents detected that were above the pipeline operator's 0.5% reporting threshold for dents. 1 dent was 12.2%, and the other 3 were less than 1%. The 12.2% dent was an ovality in a joint of pipe that was 41 feet in length.

Figure 14 4" Pipeline with an ID of 4.5", Showing an Ovality of 1"
