MFL Inspection of Small Diameter, Previously Unpiggable, Pipelines-- Lessons Learned.

by Ken Maxfield
KMAX Inspection

Pipeline Pigging and Integrity Management Conference

February 2-4, 2022

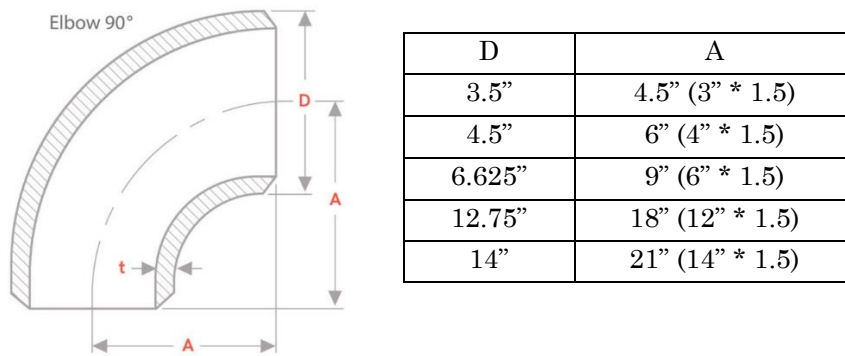
Small diameter forged elbows have a radius that is calculated on the nominal OD of the pipe size, and not the actual OD of the pipe. For example, a 3" pipe has an OD of 3.5", but the elbow radius is calculated using the nominal OD of 3". This pattern holds for all pipe sizes below 14".

Figure 1--Elbow Radius is Calculated Using the Nominal Diameter of the Pipe Instead of the Actual Diameter for all Pipe Diameters Below 14"

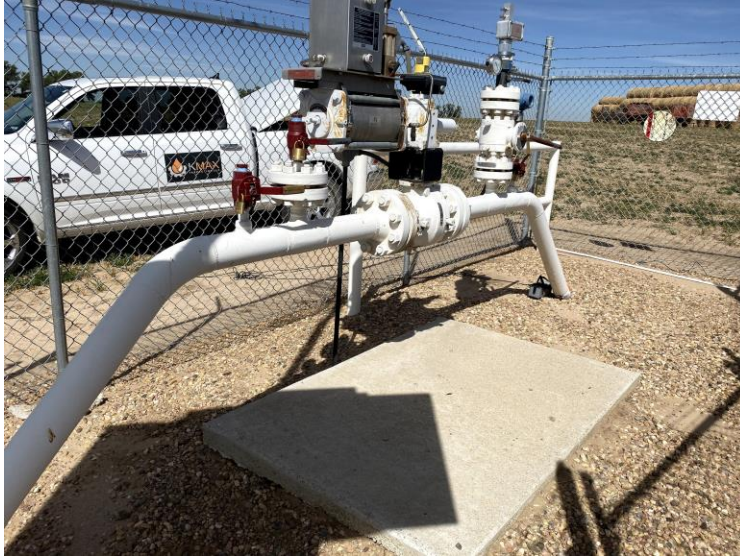
Figure 2 Above Ground Valve Setting with Heavy Wall Tee

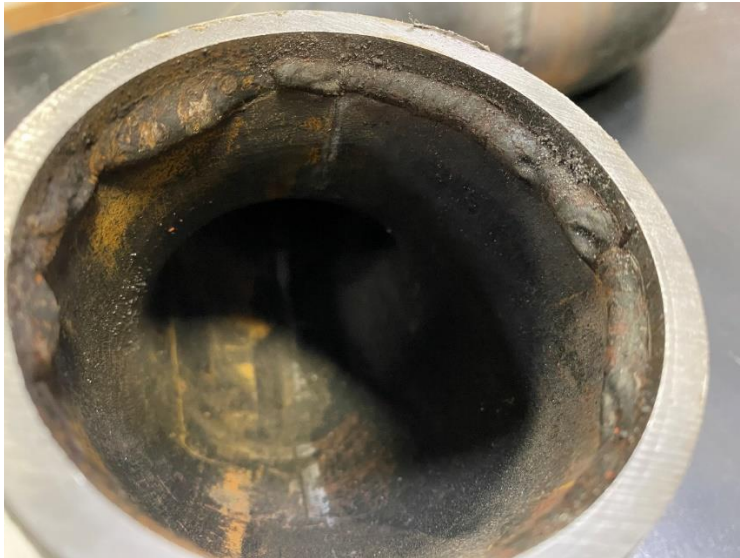
Figure 3--Heavy Weld Penetration at Transition from Straight Pipe to 1.5d Bend

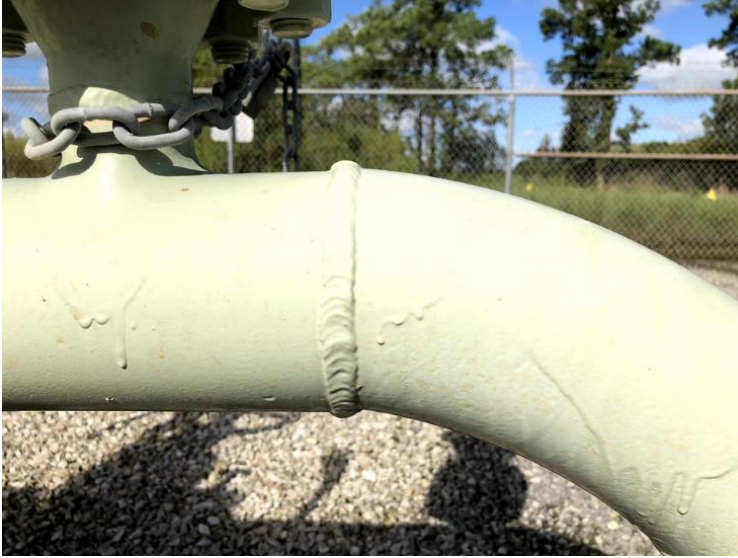
Figure 4--Location of a 3.6" Restriction in a 4" pipe--Sch. 80 Bend and Tee (Note the High/Low Weld)

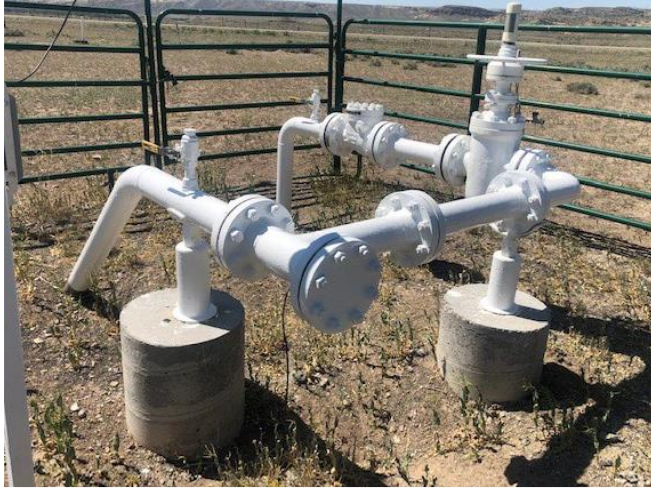
Figure 5--Launcher Site with No Trap Installed

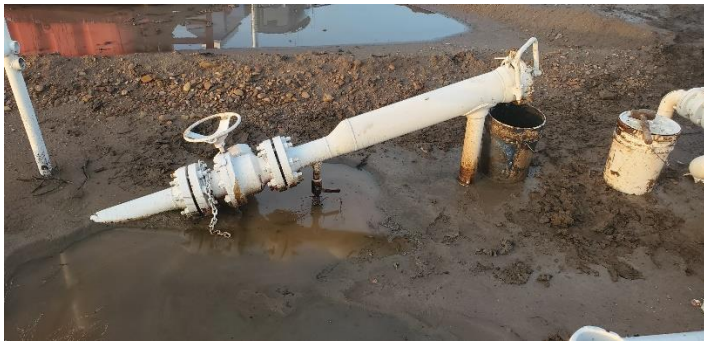
Figure 6--Launcher with Short Oversized Section and No Way to Push Product Behind the ILI Tool

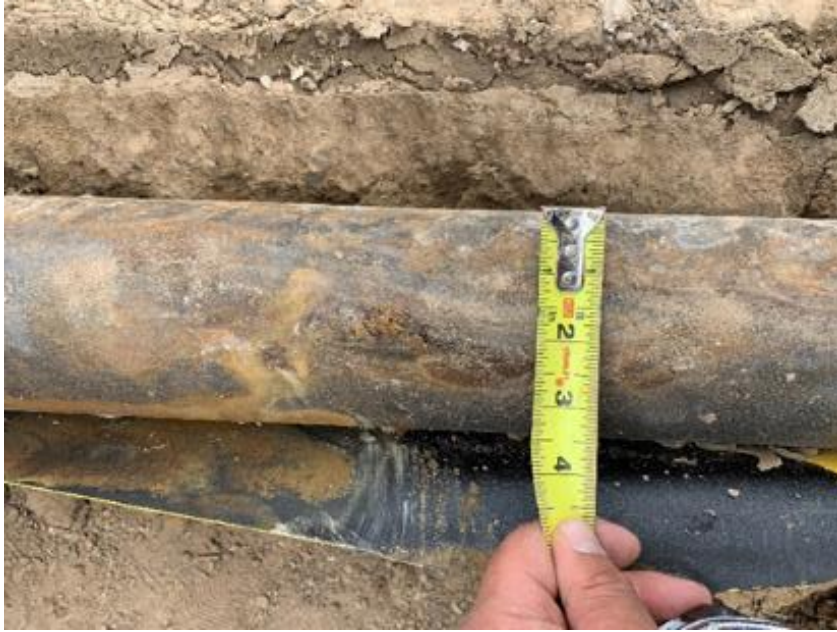
Figure 8 4" Pipe with an OD of 4.5", Showing an Ovality of 1"

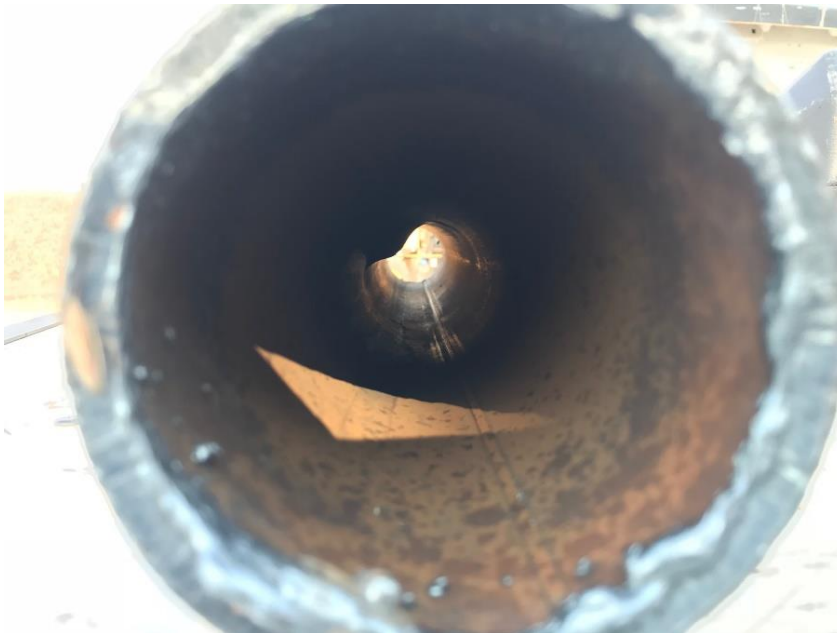
Figure 9--Dent in a 3" pipe

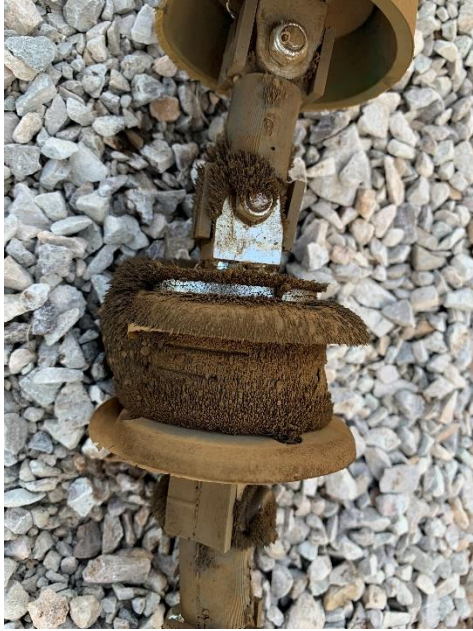
Figure 10--Magnetic Cleaning Pig with Ferrous Debris

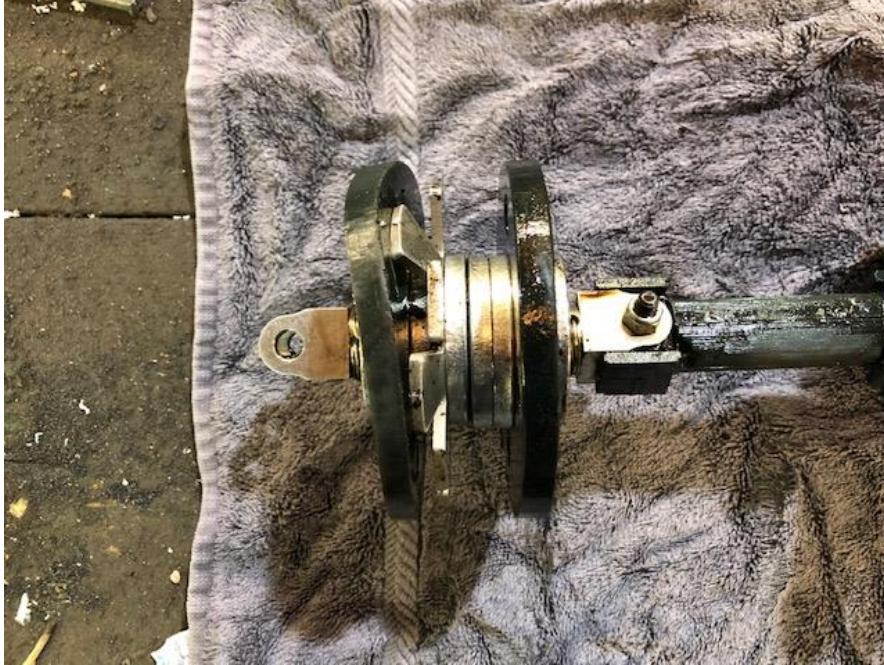
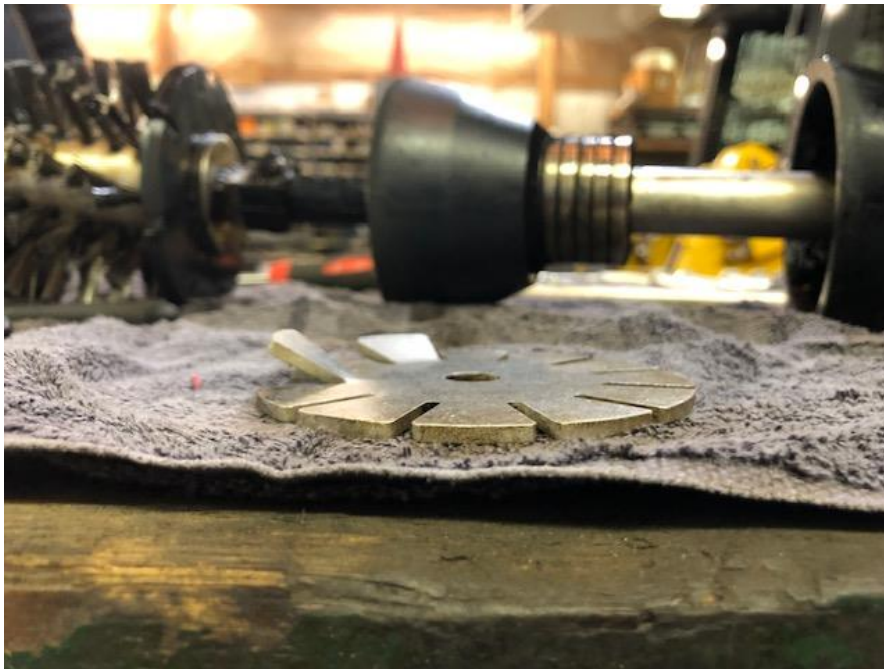
The gauge/cleaning pig was run in the pipeline with no issues. Figures 11-14 show the condition of the pig after being run through the pipeline. The gauge plate had 2 tabs slightly bent, as shown in Figure 14. After a discussion with the pipeline operator, it was decided that although the gauge plate had bent tabs, that the bore of the pipe would probably be able to pass the MFL ILI tool.

Figure 13--Gauge Plate Section of Cleaning Tool with Bent Tabs

Figure 14--Gauge Plate with Bent Tabs

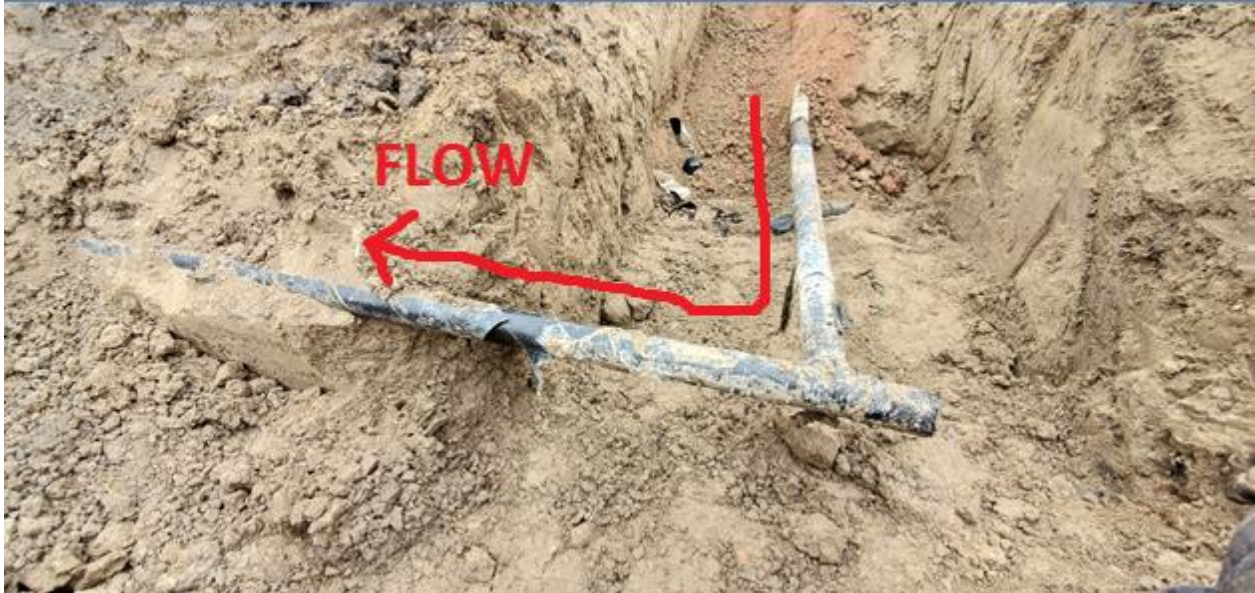
The pipeline was excavated at this location, and it was determined that a tee fitting was used as an elbow. The ILI tool was not able to navigate through the tee and became stuck in the tee. The line had to be evacuated and the ILI tool removed at this location.

Figure 15--Tee in Pipeline, Used as a 90 Degree Elbow

1. At some point in time this pipeline was modified. The crew doing the modification should have never been allowed to use a tee as an elbow.
2. Sometimes after running a gauge pig through pipeline, the results are “shades of grey” and not black and white. A calculated risk needs to be made on running an ILI tool, or running a geometry/deformation ILI tool to investigate further.
3. If the choice would have been to run a geometry/deformation tool, the same result would have occurred with an ILI tool stuck in the pipeline.

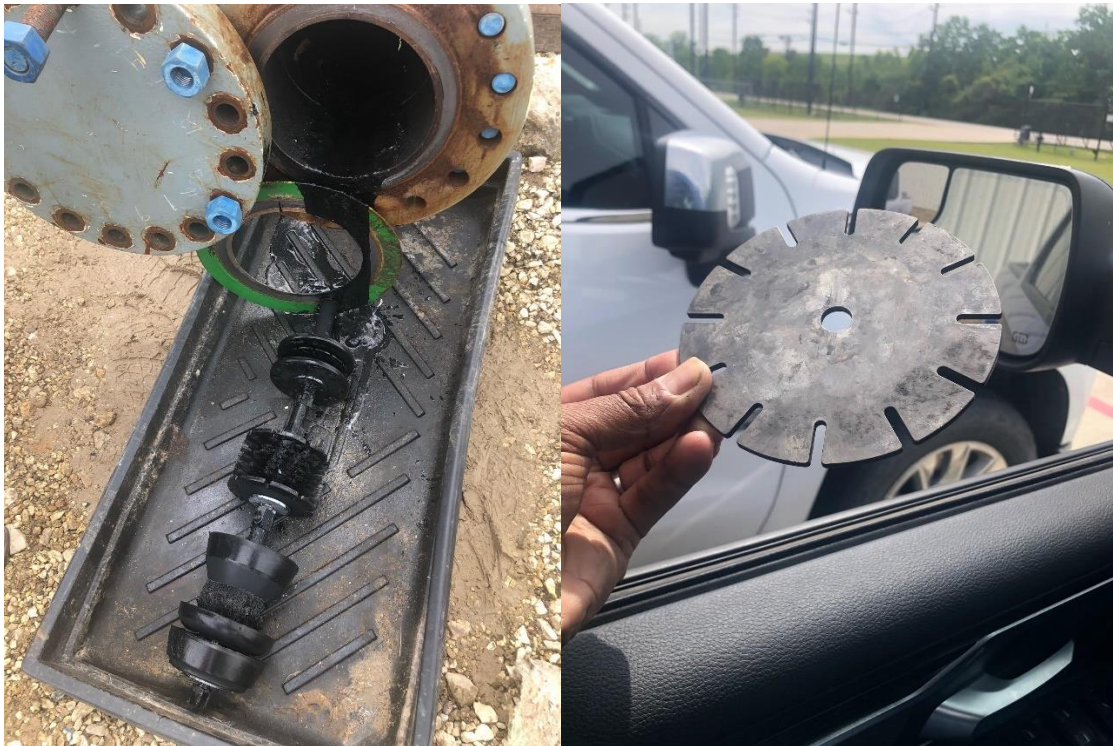
The gauge pig was run through the pipeline without issues. The results of the gauge pig were that there were no deflections of the gauge plate tabs. There was also some light ferrous material collected on the magnet.

Figure 17--Condition of the 6" Gauge Pig After Being Run Through The Pipeline

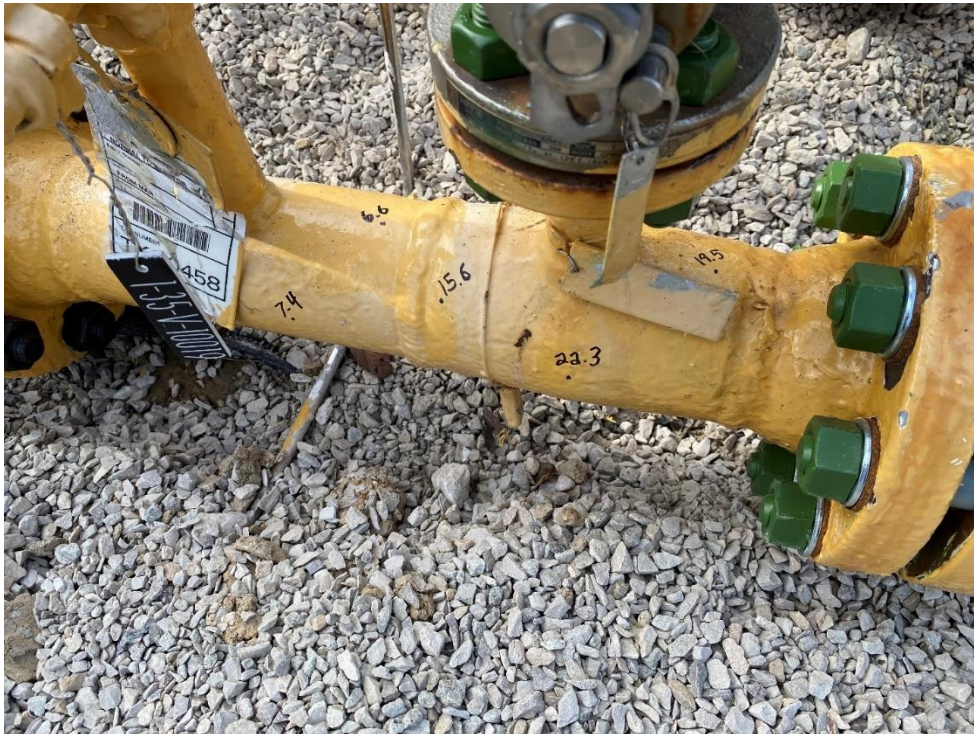
The gauge pig was run through the pipeline and became stuck in the pipeline. The operator started to investigate the location and cause of the stuck gauge pig. During that investigation, it was determined that there was a very heavy tee (wall thickness of 22.3 mm or 0.877") near the receiver. This section of the receiver was just rebuilt to get the line ready for an ILI metal loss inspection. This heavy wall tee was used as part of this reconstruction. Clearly no one was thinking about obstructions that might hang up inspection tools when this tee was installed into the new receiver configuration.

Figure 18--3" Heavy Wall Tee With Wall Thickness Up To 22.3mm(0.877")

Tees are very problematic in 3" and 4" pipelines. Tees are not inspected for bore diameter before being installed into pipelines, and many heavy wall tees are used in these pipelines. Don't select fittings that are a higher schedule of wall thickness than the nominal wall thickness of the pipeline. Also remember that there is no minimum bore requirements for fittings. ASME B16.9 states "Bore diameters away from the ends are not specified. If special flow path requirements are needed, the bore dimensions shall be specified by the purchaser."¹

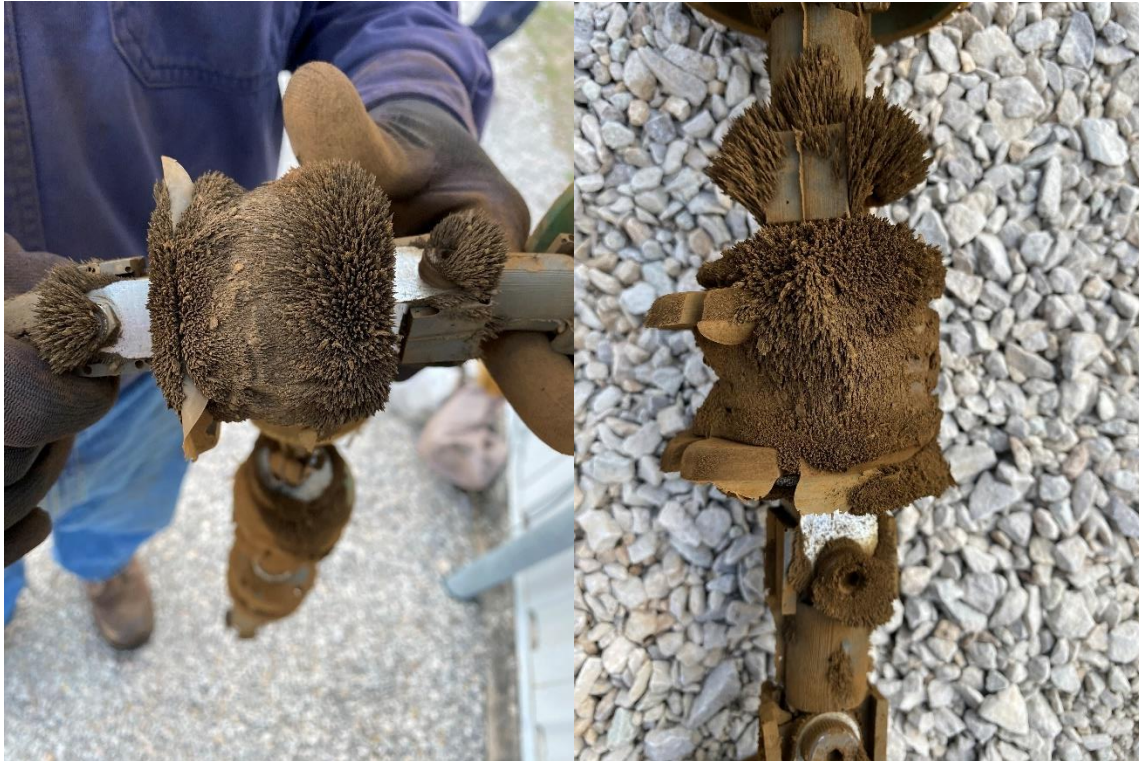
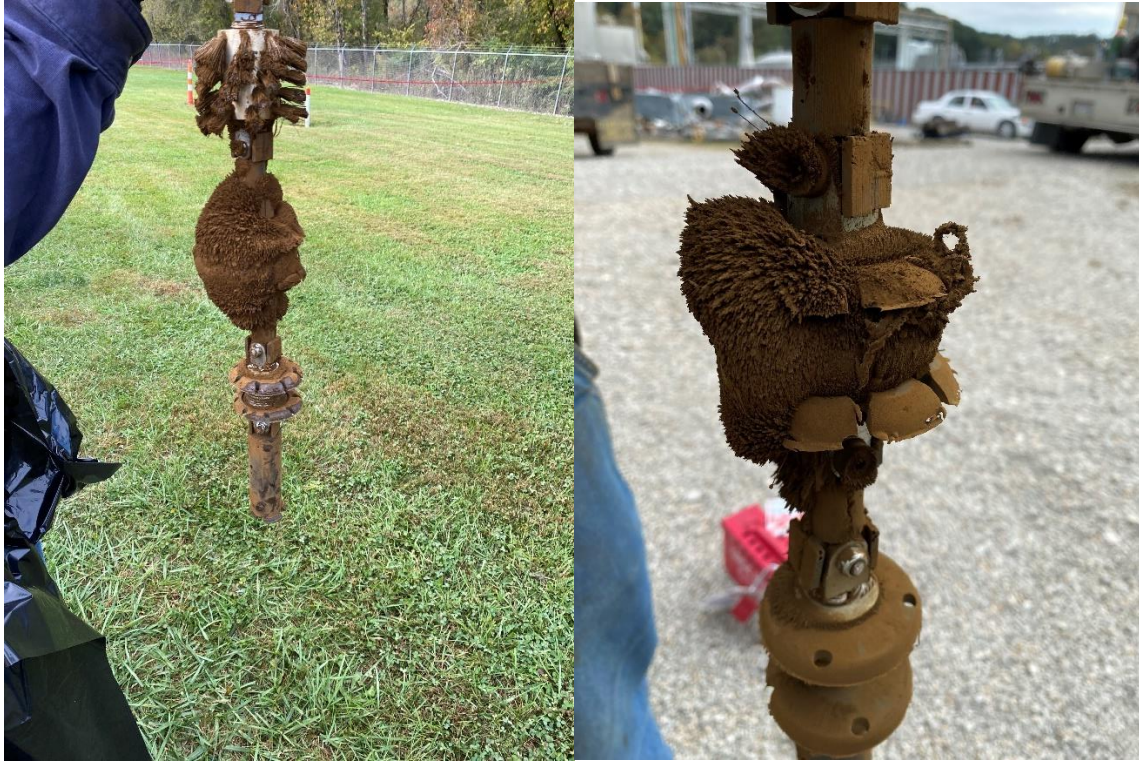
With the tee removed, and the gauge pig removed from the pipeline, another gauge pig was run through the pipeline. The gauge pig had a lot of ferrous debris attached to the magnets on the pig, and the polyurethane cups and disks were extremely worn. Additional cleaning pigs were run

through the line to remove the ferrous debris from the pipeline. The amount of debris on the pig magnet did not diminish. Eventually, 30 cleaning tools were put through the pipeline before the ferrous debris diminished. Approximately 20 pounds of debris was removed from the 3" pipeline that was only 3,500' in length.

Figure 19--Magnetic Cleaning Pig Results, with Ferrous Debris Attached to the Magnet

Figure 20--Magnetic Cleaning Pig Results, with Ferrous Debris Attached to the Magnet

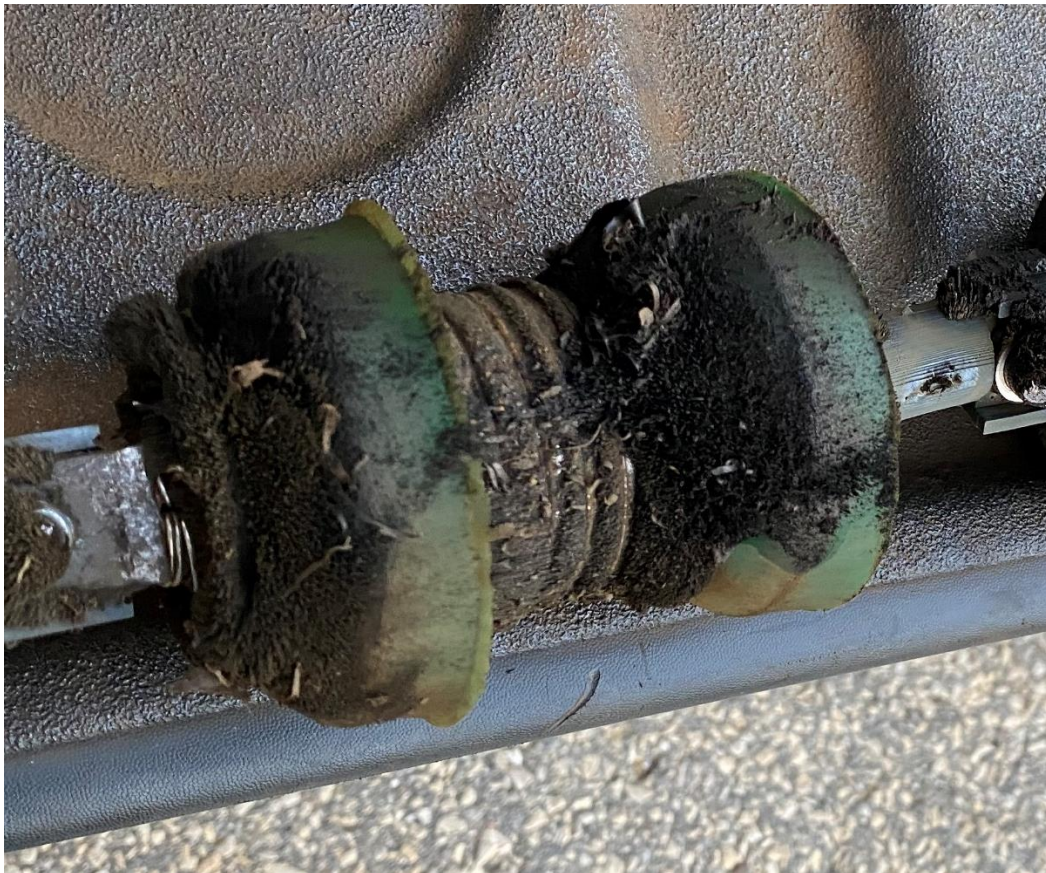
Figure 21--Final Magnet with Reduced Ferrous Debris
