Combination MFL/Deformation Inspections of Small-Diameter Unpiggable Pipelines.

by Ken Maxfield
KMAX Inspection

Pipeline Pigging and Integrity Management Conference

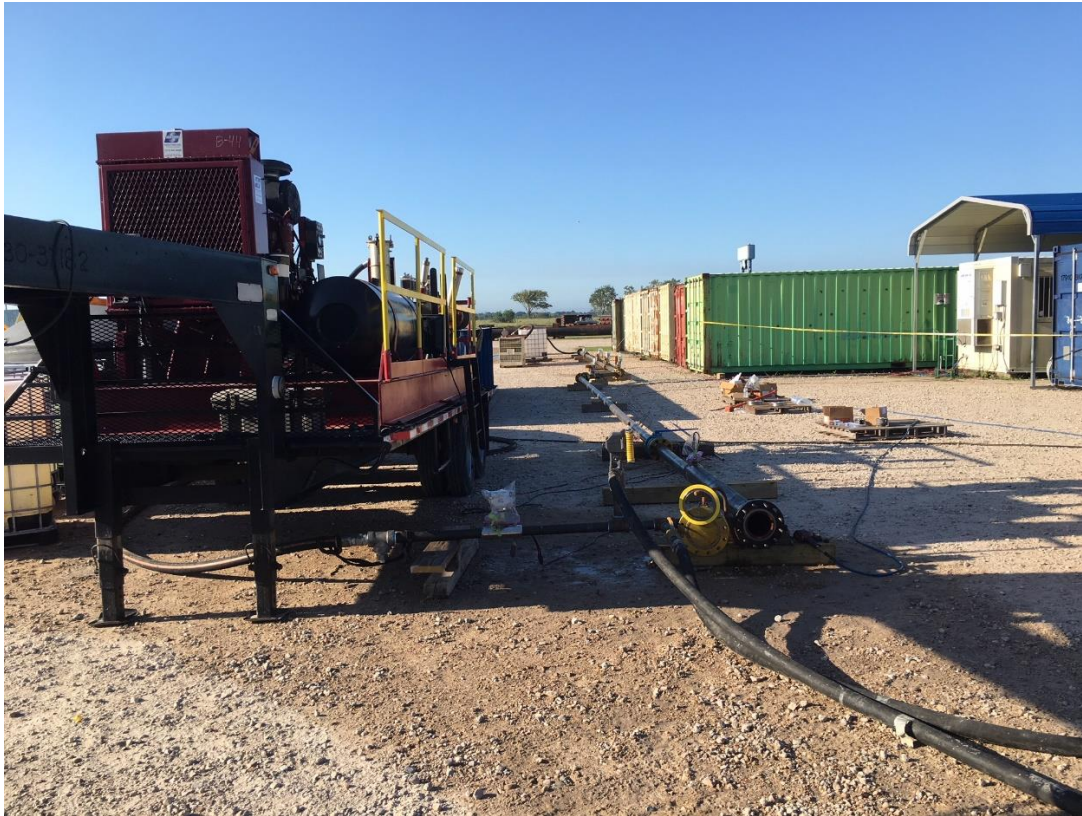
Figure 2 Test Pipe Showing Launcher and Receiver, Bends, and Pump

A testing facility was contracted to create the same pipe configuration as the valve sites in the pipeline. This included a section of straight schedule 80 pipe, a 45-degree 3d bend, a short section of schedule 80 pipe, another 45-degree, 3d bend, and another section of straight pipe.

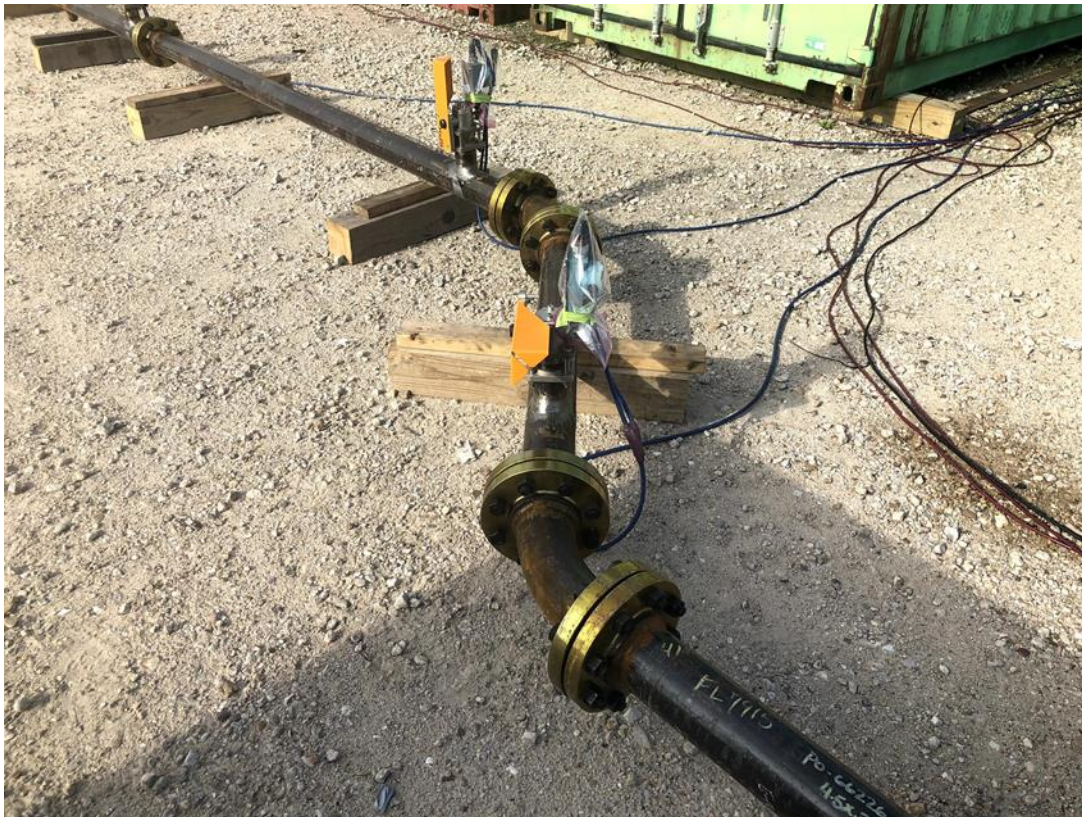
Figure 3 Test Pipe with Flanges on the End of Bends

The difficult part of designing the test pipe configuration was figuring out how to simulate the restrictions that were detected in the pipeline. Several ideas were discussed, but the best idea was to place flanges at the ends of the 45-degree, 3d bend. A steel ring could then be inserted in between the flanges to simulate the restrictions. This design would allow the rings to be changed out expeditiously to test different diameters of restriction. It would also allow rings to be fabricated to a very high tolerance level. The rings were designed with full circumferential restrictions. Four different ring sizes were chosen. The inside ring diameters ranged from 3.7" to 3.55". A total of five flanges were installed in the test pipe.

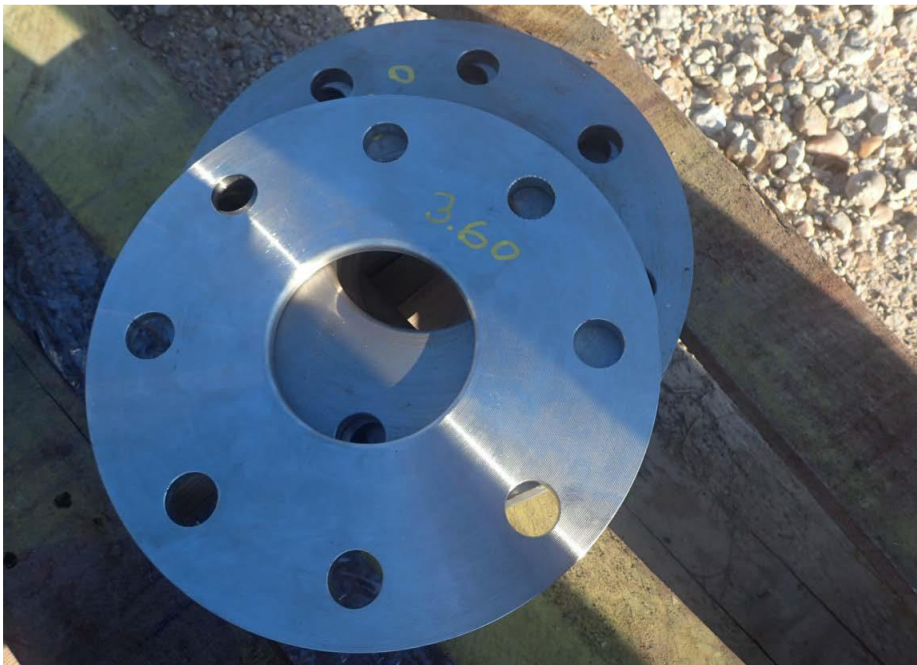
Figure 4 Restrictive Rings Installed Between Flanges

Over a four-day period, 21 tests were conducted in the test pipe. The first test was conducted with no rings in the system. The largest diameter ring (3.7") was next to be inserted in the system. Smaller rings were then introduced working down to the 3.55" diameter rings. Several tests were run with the 3.55" rings. The tool was stopped at various positions in the test pipe. The tool was stopped prior to the first bend, in the middle of the first bend, between bends and in the middle of the second bend.

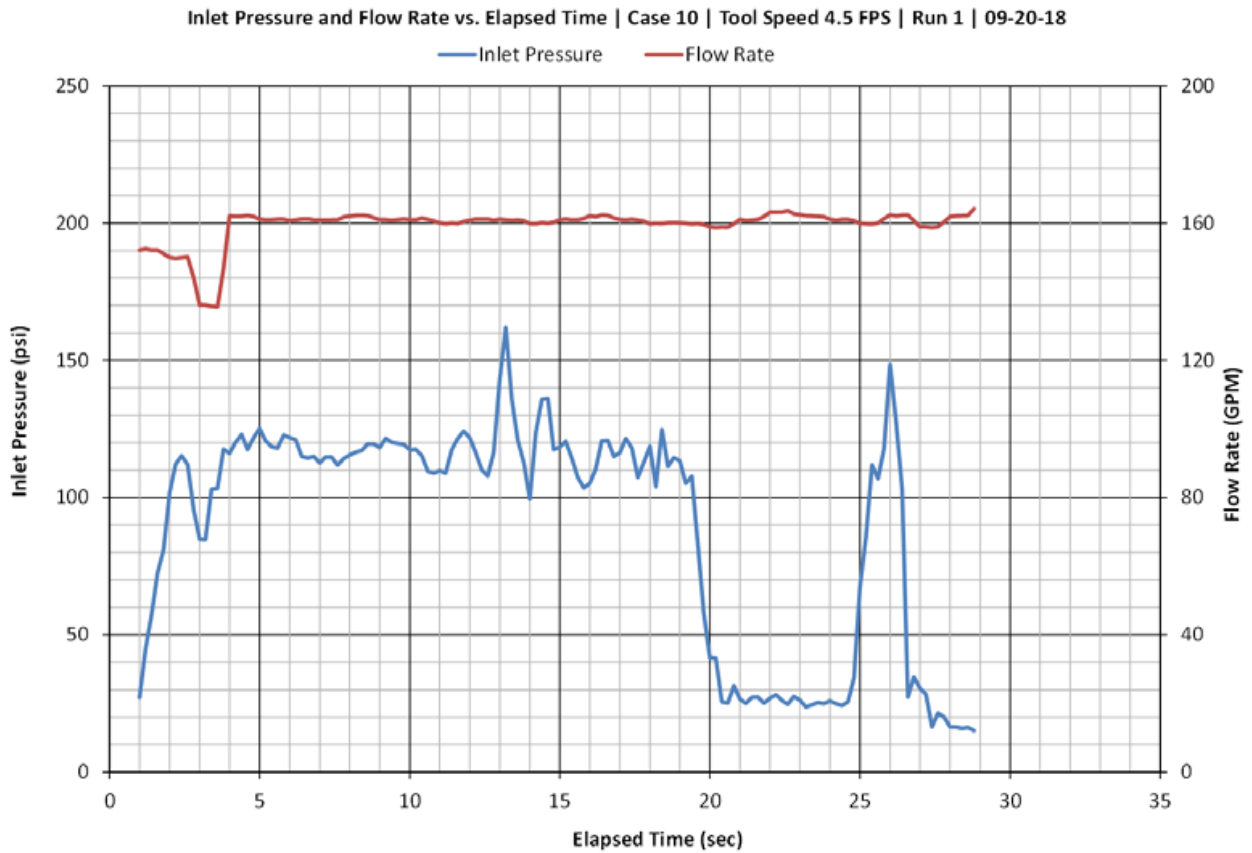
Figure 5 Pressure and Flow of Test Pipe with 3.55 Diameter Rings, with No Stopping

The test system was fitted with a pressure monitoring system to measure the pressure it took to push the tool through the test pipe. Each test was monitored to detect pressure spikes when stopping and starting the ILI tool. Figures 5 and 6 show the pressure profile of the ILI tool in the test pipe with 3.55" diameter rings. Figure 5 is without stopping, and Figure 6 is with stopping the ILI tool in each of the two bends. The maximum pressure detected was 163 psi. There is a section of schedule 40 pipe near the end of the test pipe. The pressure to push the tool through the schedule 40 pipe was less than 30 psi.

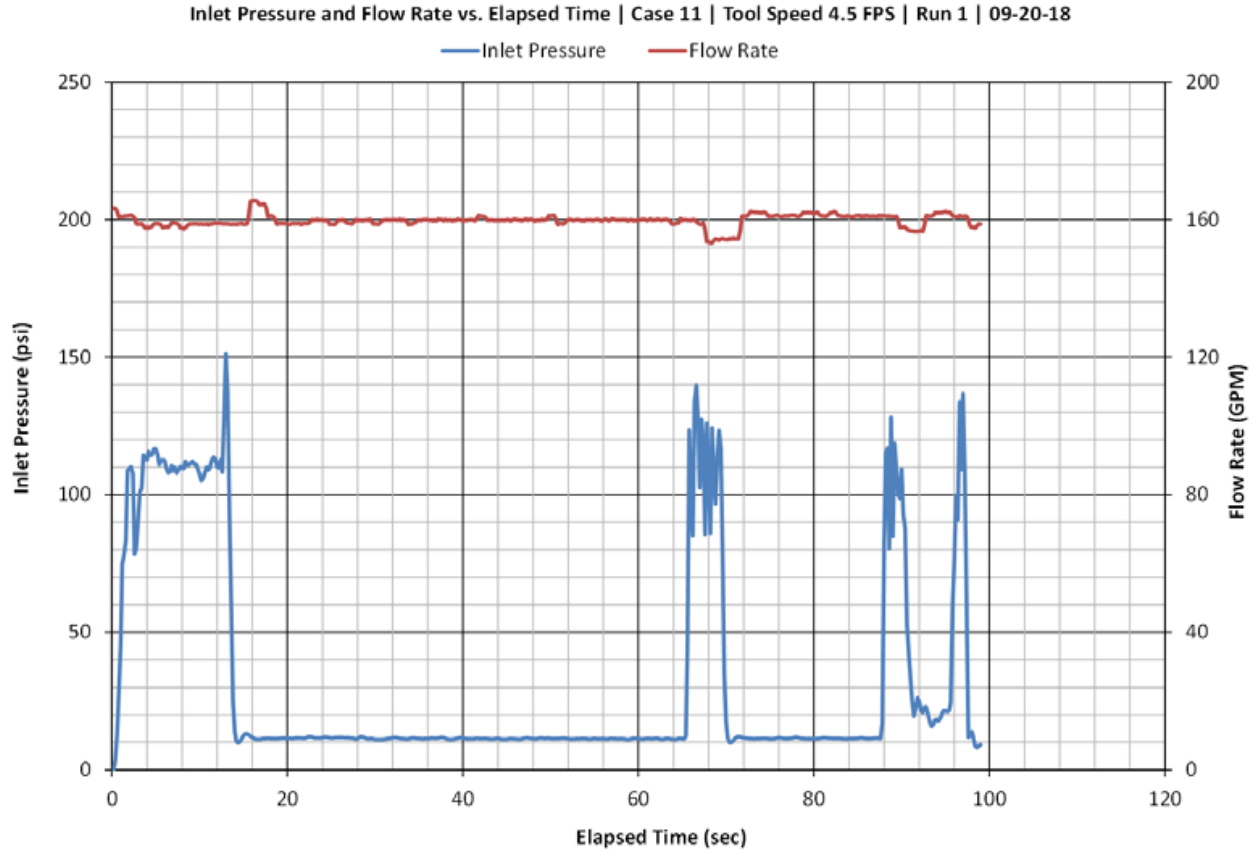
Figure 6 Pressure and Flow of Test Pipe with 3.55 Diameter Rings, with Two Stops

Throughout all the test scenarios the ILI tool never stuck in the restrictions. At the conclusion of the testing phase the operator had a very high confidence level the ILI tool would not stick in their pipeline and recommended that we move forward with the inspection of the 4", 10-mile-long pipeline.

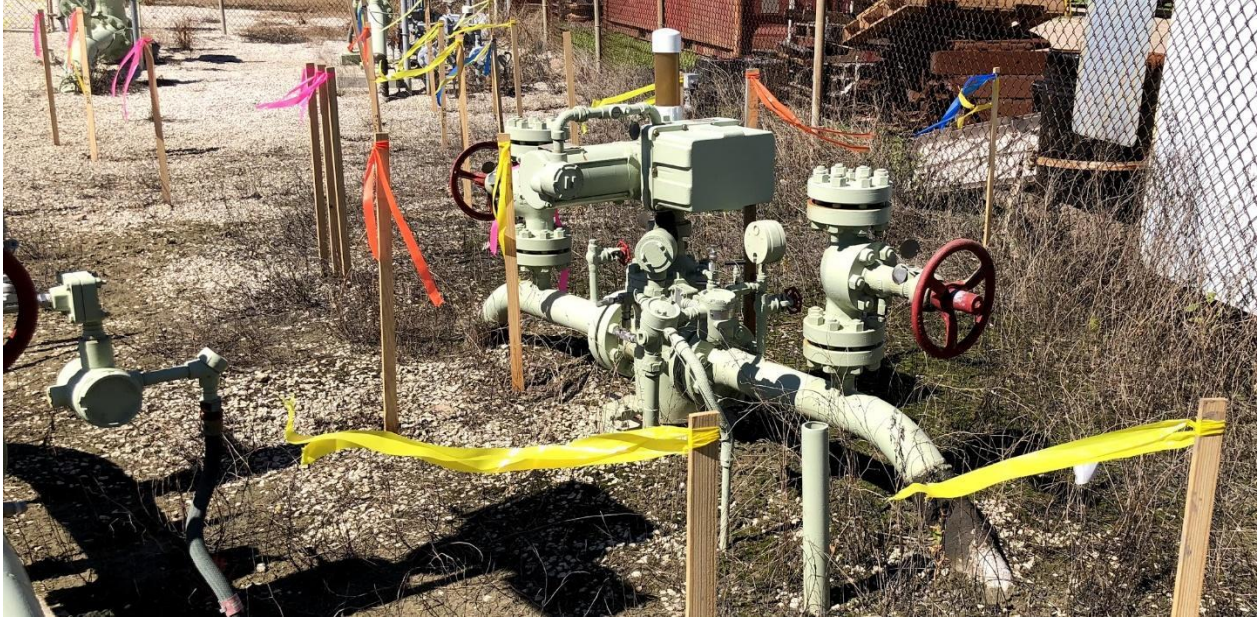
Figure 7 One Call Stakes at Valve Site

The pipeline operator still wanted to be prepared for the possibility of sticking a tool in their line. They came up with a plan to have "one calls" made for both valve sites and have tested replacement pipe on hand prior to running the ILI tool to minimize down time on the pipeline should the ILI tool get stuck in the line.

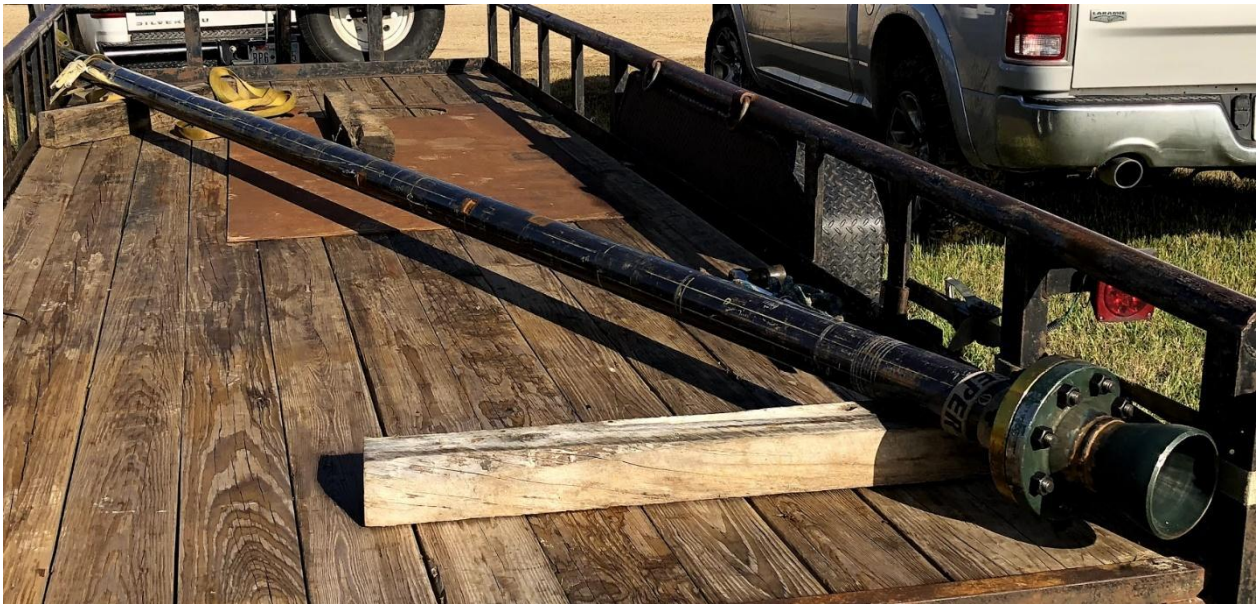
Figure 8 Calibration Spool of 4" Sch. 40 Pipe

The pipeline operator created a calibration spool of 4" schedule 40 pipe that contained both internal and external metal loss features as well as dents. The spool was brought to the launcher and prior to launching the ILI tool, the pipeline operator pulled the ILI tool through the spool with a strap using a pickup truck. This spool would allow the operator to validate the performance of the ILI tool.

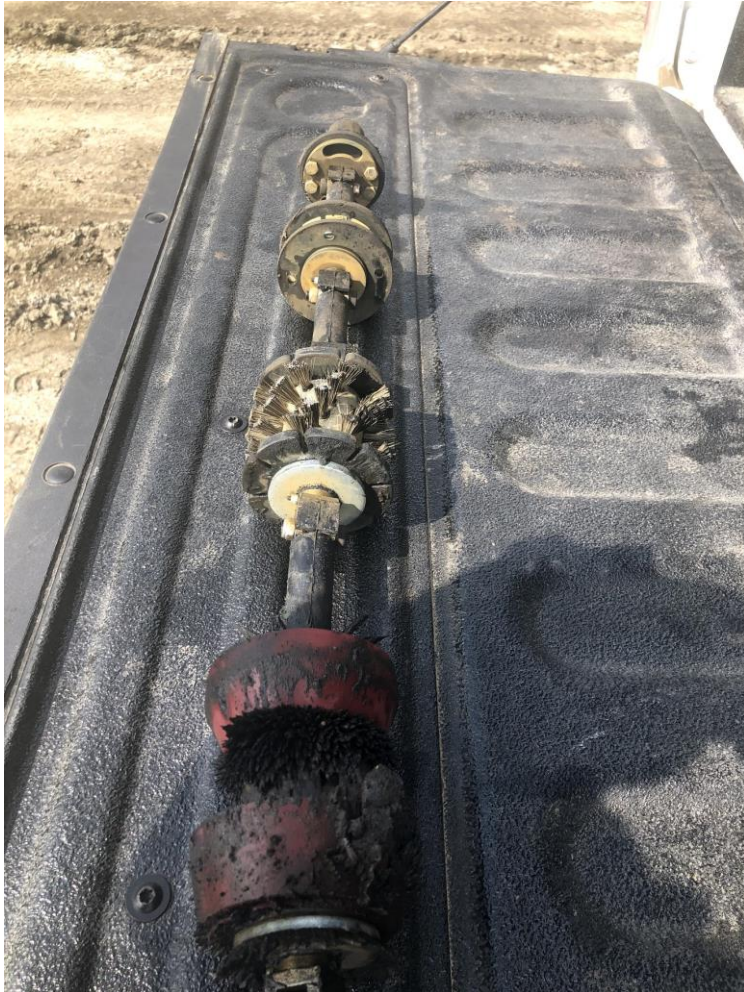
Figure 10 KMAX Cleaning/Gauge Pig with Magnets, Brush, Gauge Plate, and 22hz transmitter

The first cleaning pass of the cleaning/gauge pig was conducted. The pig got stuck in the nominal pipe of the receiver after passing through the receiver valve. The receiver was disassembled, and the cleaning/gauge pig was removed from the pipe with a winch. The cleaning/gauge pig got stuck on a heavy weld in heavy wall pipe in the receiver. The pump truck, which was capable of providing 100 PSI, could not produce enough pressure to move the cleaning/gauge pig past the weld. There were two options to remedy this situation. Get a pump that would provide higher pressure or reconfigure the pipe in the receiver. It was decided to reconfigure the pipe at the receiver, due to time constraints to get the line back into service.

The cleaning/gauge pig had ferrous debris on it after the first pass, so it was decided to run the pig a second time to get the line clean.
