MFL Inspection of Small Diameter, Previously Unpiggable, Pipelines-- Lessons Learned.

by Ken Maxfield
KMAX Inspection

Pipeline Pigging and Integrity Management Conference

February 2-4, 2022

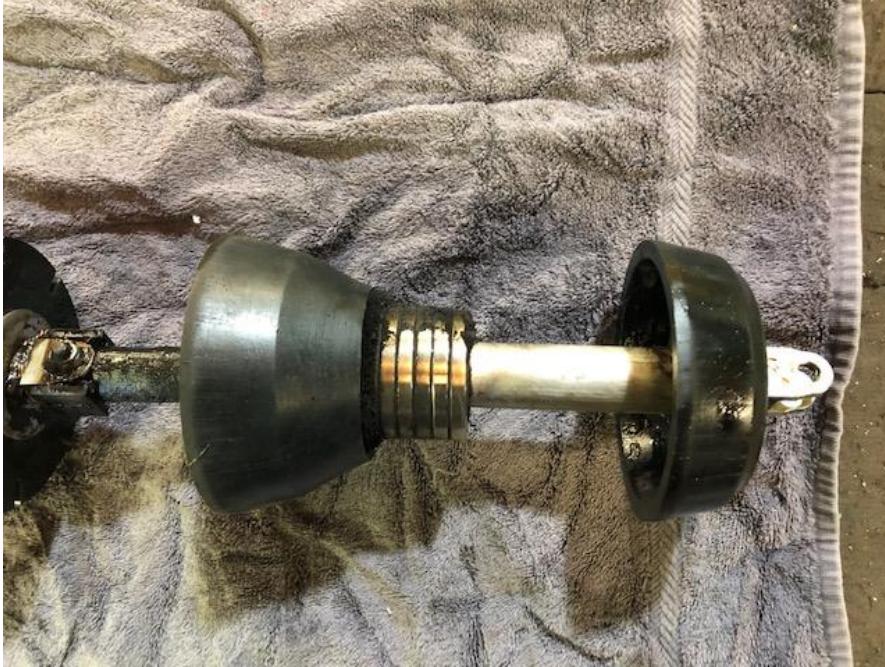
The gauge/cleaning pig was run in the pipeline with no issues. Figures 11-14 show the condition of the pig after being run through the pipeline. The gauge plate had 2 tabs slightly bent, as shown in Figure 14. After a discussion with the pipeline operator, it was decided that although the gauge plate had bent tabs, that the bore of the pipe would probably be able to pass the MFL ILI tool.

Figure 11--Drive Section of Cleaning Tool with Magnet After Being Run in the Pipeline

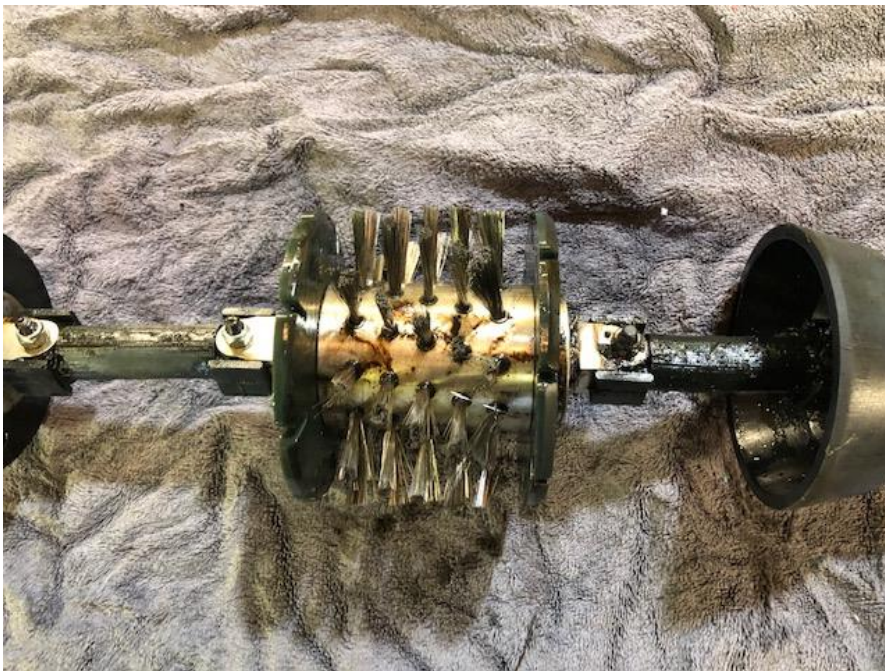
Figure 12--Brush Section of Cleaning Tool After Being Run in the Pipeline

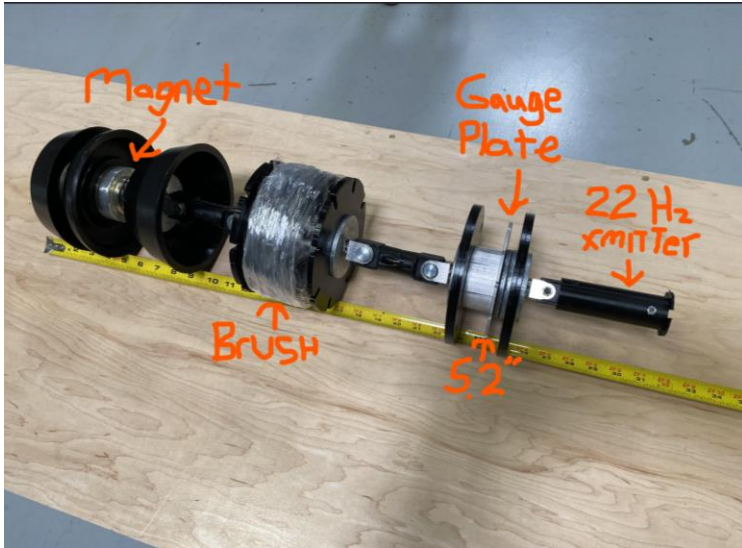
KMAX provided the operator a 6" gage plate pig, which has a magnetic drive section and a gauge plate section with a 5.2" plate (reported minimum ID for the line is 5.1"). This tool would also employ a 22-Hz transmitter to aid in locating the tool should it become lodged.

Figure 16--6" Gauge Pig Configuration
